Pike Chain of Lakes
Bayfield County, Wisconsin
2023 EWM Management & Monitoring Report
April 2024

Created by: Todd Hanke, Kelsey Wilcox, Eddie Heath, & Tim Hoyman
Onterra, LLC
De Pere, WI

Funded by: Iron River Pike Chain of Lakes Association
Wisconsin Dept. of Natural Resources (ACEI-291-22, ACEI-332-23)

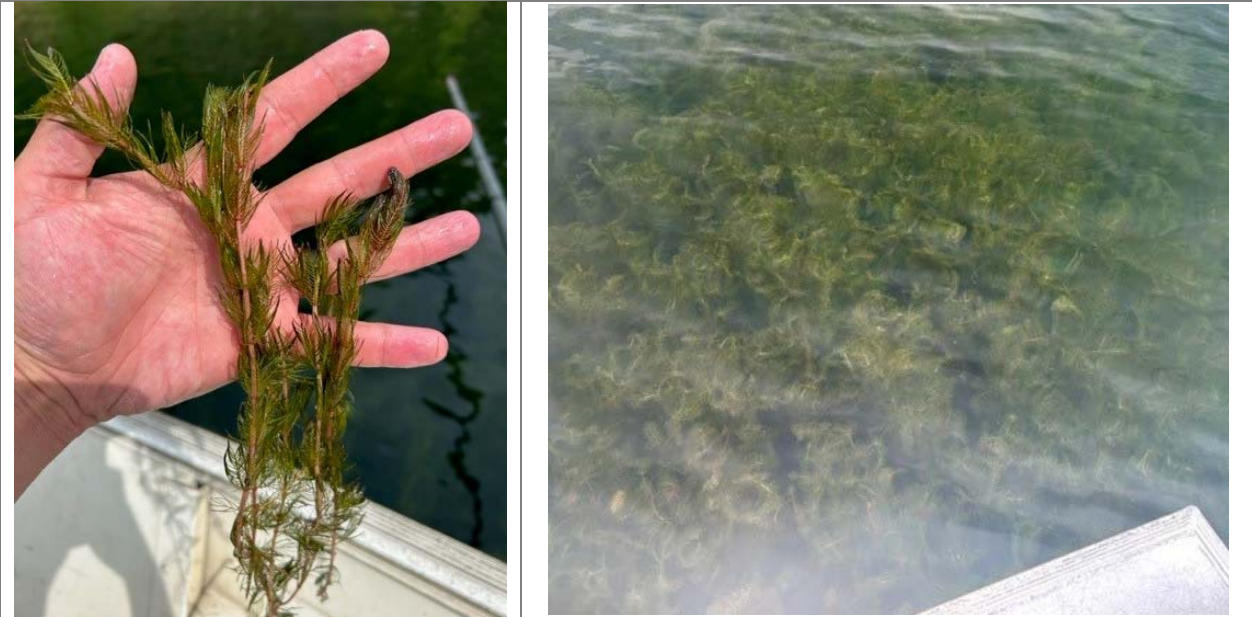
Photograph 1.3-1. Actively growing EWM observed during Pretreatment Survey. Photo credit Onterra.

Onterra ecologists conducted the Pretreatment Confirmation and Refinement Surveys on the Pike Chain on June 12 and 13, 2023. Aside from the collection of the pretreatment sub-sample point-intercept aquatic plant data, the survey evaluated the growth stage of the EWM population in the treatment areas as well as confirmed the average depth of the sites for dosing purposes. The survey was conducted using a combination of survey methods, but largely consisted of visual observations as the EWM was visible from the surface. Water temperatures at mid-depth were about 68°F. Using an optical probe, the pH was measured at 8.4 in Buskey Bay and 8.2 in Lake Millicent. New EWM growth was apparent on the target plants and appeared to be in an active growth stage ideal for treatment (Photo 1.3-1). The relative accuracy of the average depth of the treatment sites were confirmed. No alterations were recommended to the treatment plan as a result of the pretreatment survey.

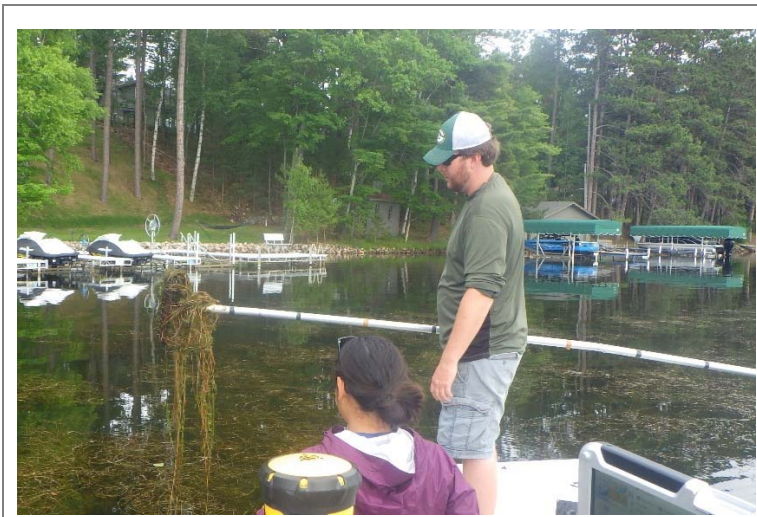
Photograph 2.0-1. Point-intercept survey on a WI lake.
Photo credit Onterra.

While the point-intercept survey is a valuable tool to understand the overall plant population of a lake, it does not offer a full account (census) of where a particular species exists in the lake. During the EWM mapping survey, the entire littoral area of the lake is surveyed through visual observations from the boat.

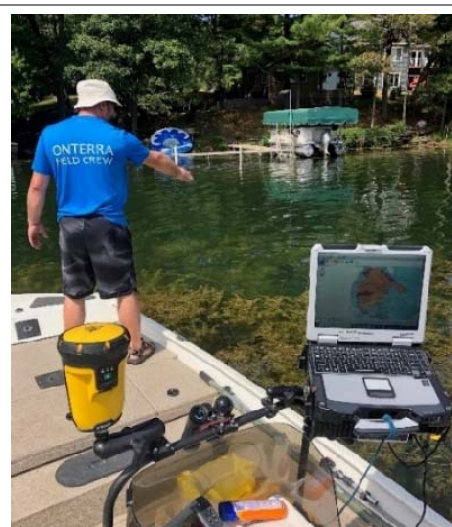
Photograph 2.0-2. EWM mapping survey on a Wisconsin lake.
Photo credit Onterra.

Field crews supplement the visual survey by deploying a submersible camera along with periodically doing rake tows. The EWM population is mapped using sub-meter GPS technology by using either 1) point-based or 2) area-based methodologies. Large colonies >40 feet in diameter are mapped using polygons (areas) and are qualitatively attributed a density rating based upon a five-tiered scale from *highly scattered* to *surface matting*. Point-based techniques were applied to AIS locations that were considered as *small plant colonies* (<40 feet in diameter), *clumps of plants*, or *single or few plants*. Annual late-summer EWM mapping surveys serve to evaluate the management occurring on the system.

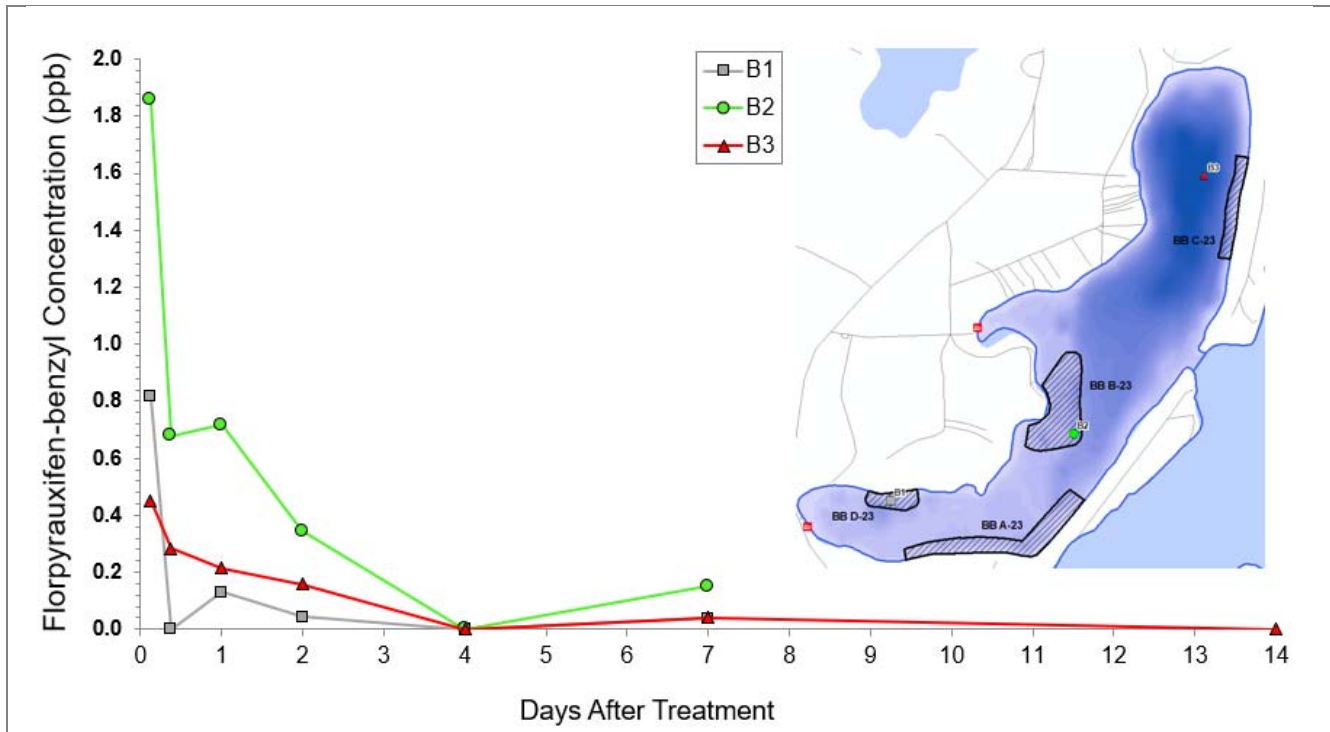
Figure 3.1-1. Buskey Bay 2023 Florpyrauxifen-benzyl concentration monitoring results. All samples collected after 14 DAT were below detection limits.

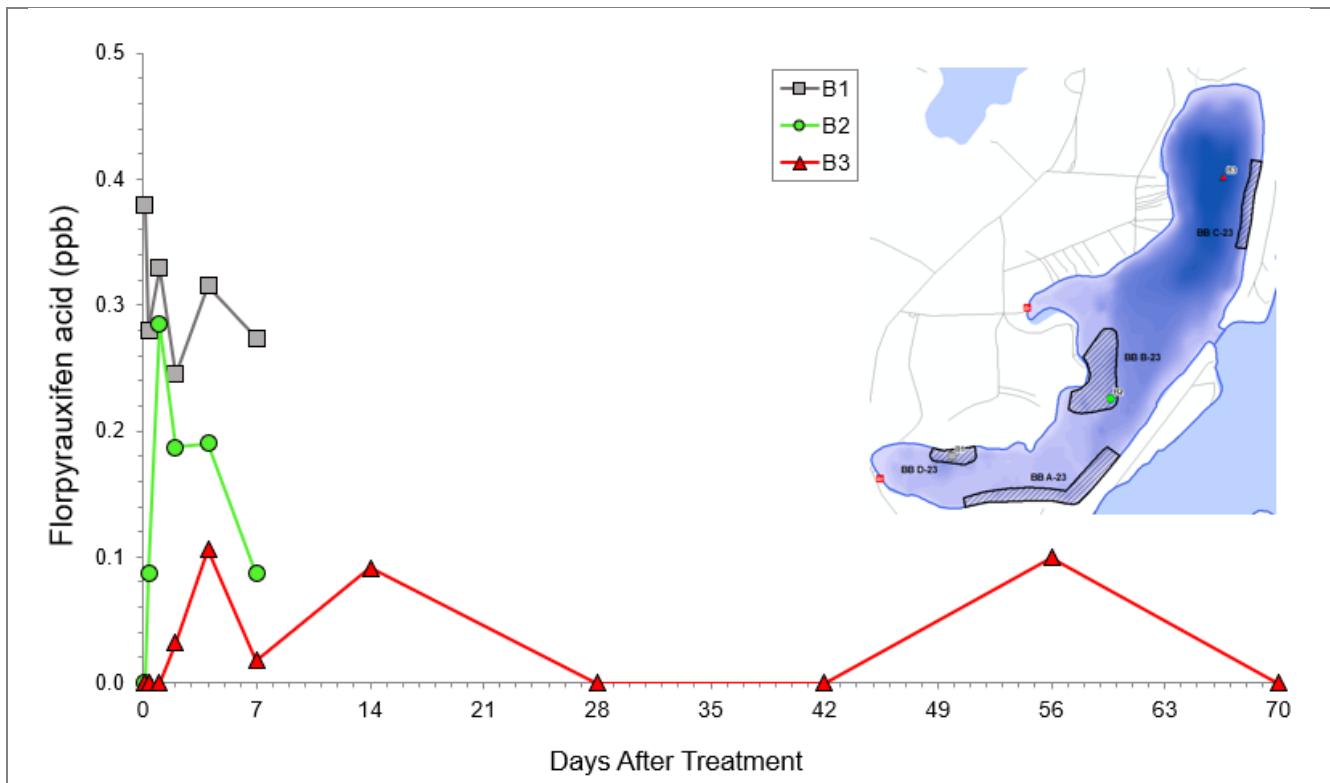
Figure 3.1-2. Buskey Bay 2023 Florpyrauxifen acid concentration monitoring results.

Concentrations florpyrauxifen acid are displayed on Figure 3.1-2. Acid concentrations were higher at sites within application areas (B1 & B2) compared to the untreated site (B3) during samples collected out to 7 DAT. All samples collected after 7 DAT were from site B3 and were above detection limits at around 0.1 ppb at 14 DAT and 56 DAT while being below detection limits at 28 DAT, 42 DAT, and 70 DAT.

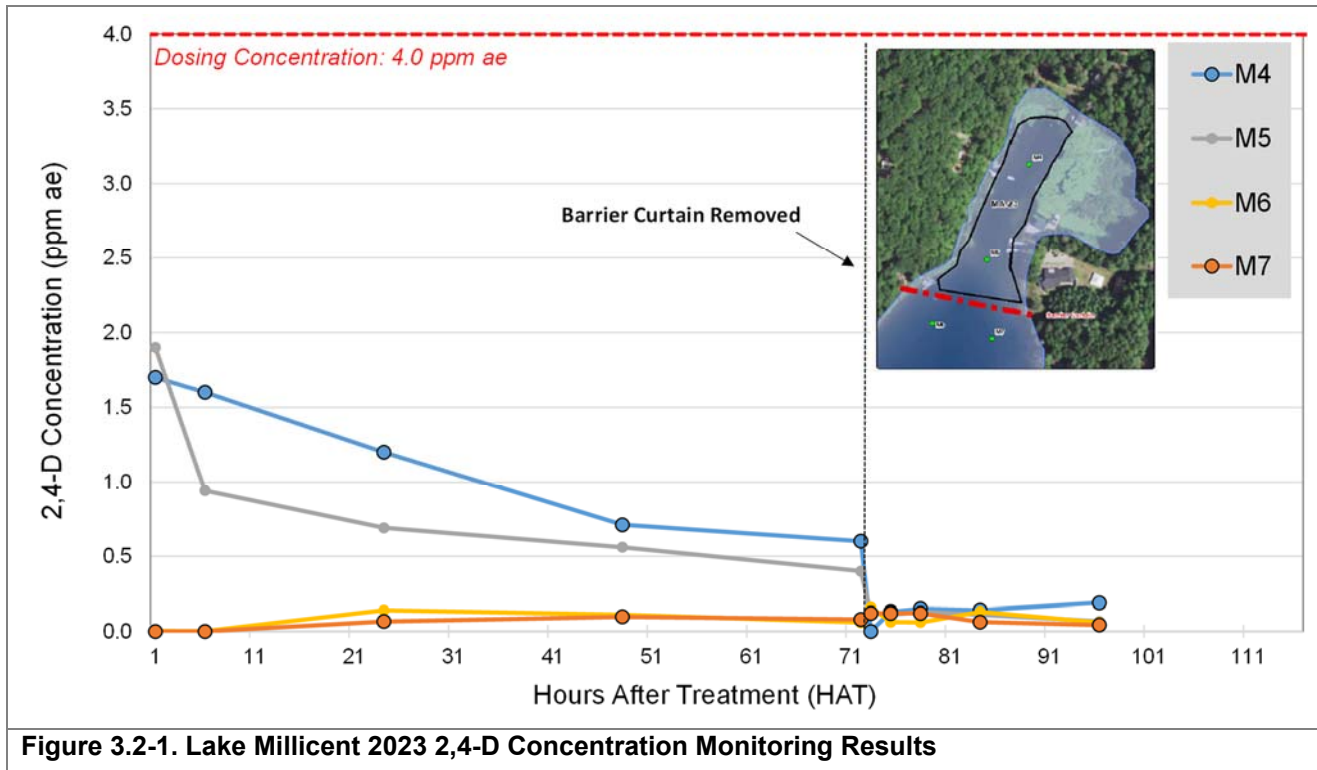
Figure 3.2-1 displays the concentration of 2,4-D at the four monitoring locations in parts per million (ppm) to be consistent with the units of the dosing strategy (4.0 ppm ae). Concentrations of the herbicide were approximately half of the target rate from samples collected within the barrier curtain with the highest concentration measured at 1.7 and 1.9 ppm from sites within the barrier curtain at 1 HAT. Concentrations gradually decreased from samples collected within the barrier to approximately 0.6-0.7 ppm at 72 HAT just prior to curtain removal. By comparison, minimal 2,4-D was detected in either of the two sampling sites located outside the barrier while the barrier was in place. This indicates that the barrier curtain functioned as intended with minimal herbicide loss. Once the barrier curtain was removed, concentrations decreased rapidly within the treatment site as the herbicide dissipated within surrounding waters. At the final sampling interval 24 hours after the curtain removal, detectable levels of 2,4-D were measured at all four monitoring sites, with the highest concentration of 0.19 ppm collected from site M4.

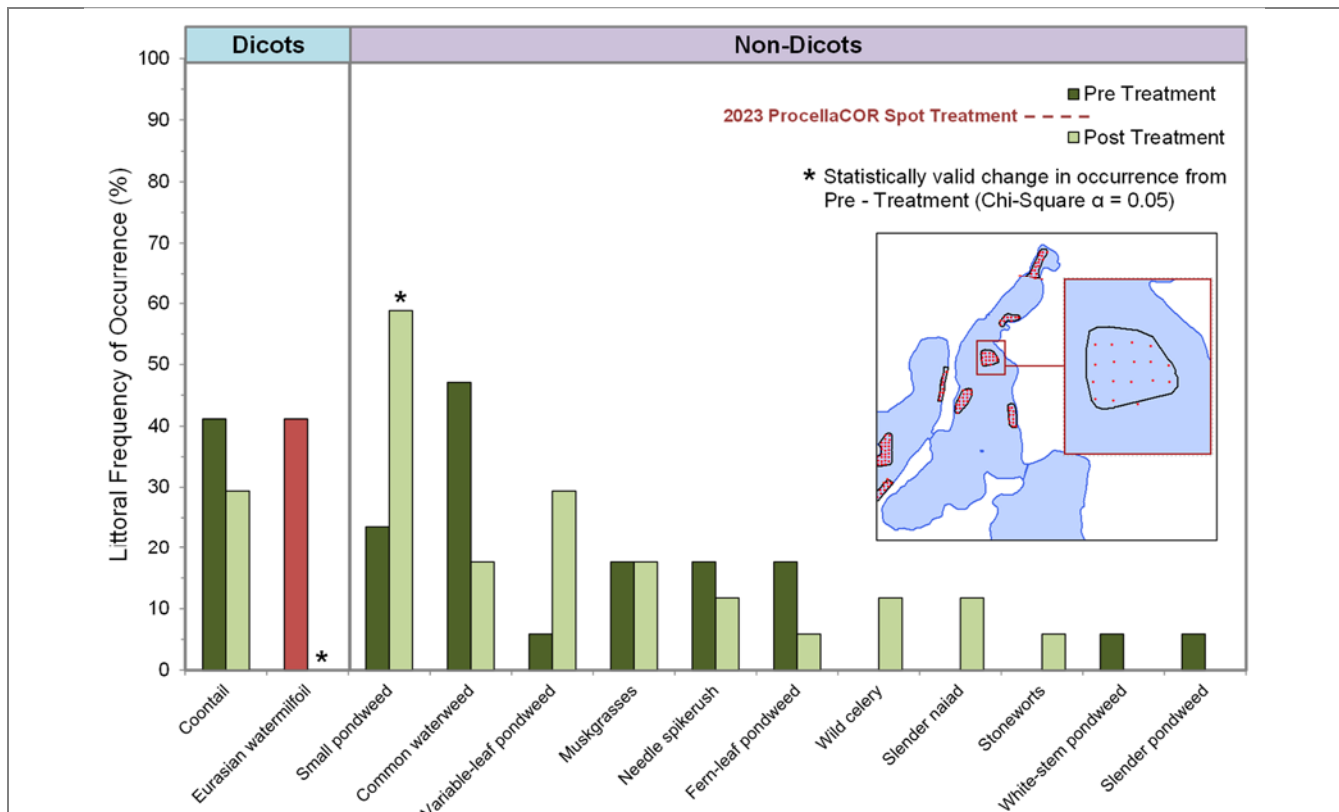
Figure 3.3-5. Littoral frequency of occurrence of aquatic plants Site M D-23 in Lake Millicent. Asterisk represents statistically valid change from June 2023 to September 2023 (Chi-Square $\alpha = 0.05$). n=17.

Quantitative monitoring consisted of the completion of a sub-sample point-intercept survey from 17 sampling locations within the application area. Analysis of these data show that the occurrence of EWM was reduced from 41.2% prior to treatment to 0% in the post-treatment survey (Figure 3.3-5). The occurrence of small pondweed showed statistically higher occurrences in the post-treatment survey. With the exception of EWM, no statistically significant declines of native plants were observed.

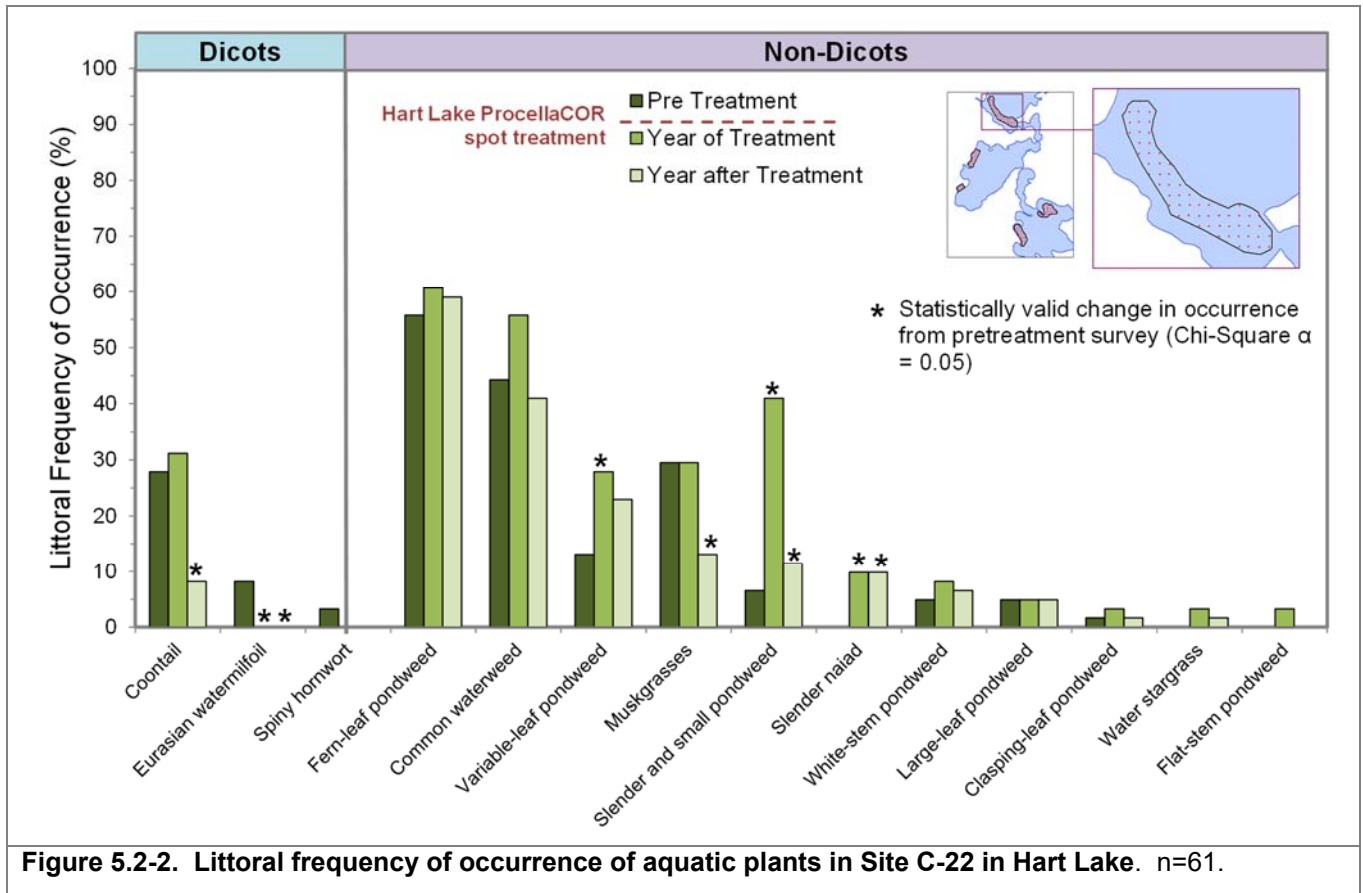
Figure 5.2-2. Littoral frequency of occurrence of aquatic plants in Site C-22 in Hart Lake. n=61.

Quantitative monitoring consisted of the completion of a sub-sample point-intercept survey from 61 sampling locations within the application area. Analysis of these data show that the occurrence of EWM was reduced from 8.2% prior to treatment to 0% in the post-treatment survey (Figure 5.2-2). The occurrence of small pondweed, variable-leaf pondweed, and slender naiad showed statistically higher occurrences in the post-treatment survey during the year of treatment. Coontail and muskgrasses each showed valid decreases in occurrence between 2022-2023, but these species did not show changes in occurrence comparing pretreatment (2021) to year of treatment (2022).

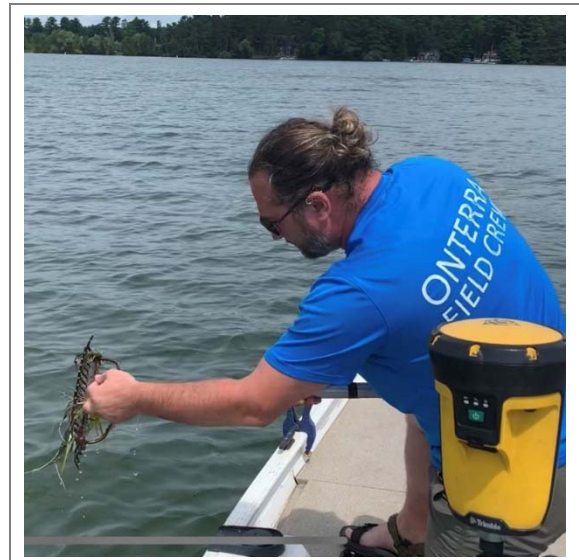
Photograph 6.0-1. Point-intercept survey on a WI lake. Photo credit Onterra.

The point-intercept method as described in the WDNR publication (WDNR PUB-SS-1068 2010) was used to complete this study. This survey allows for a quantitative analysis of the aquatic plant community in the lake and is directly comparable to past or future surveys completed with the same methodology. Onterra ecologists completed a whole-lake point-intercept survey on the Pike Chain of Lakes on August 8-9, 2023 (Photograph 6.0-1). The results of the 2023 point-intercept survey are highlighted below as well as a comparison of the past surveys that have been completed to date.

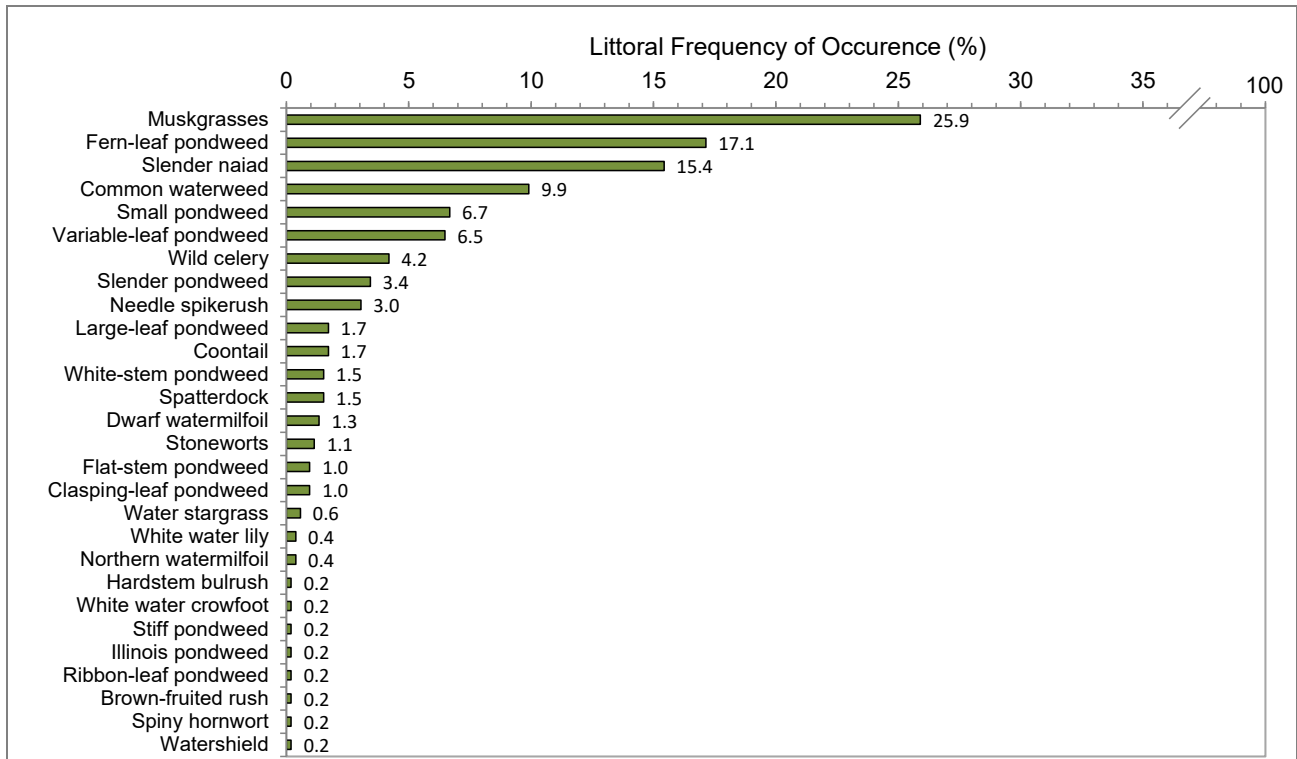
Figure 6.3-1. 2023 Littoral Frequency of Occurrence of aquatic plant species in Hart Lake.

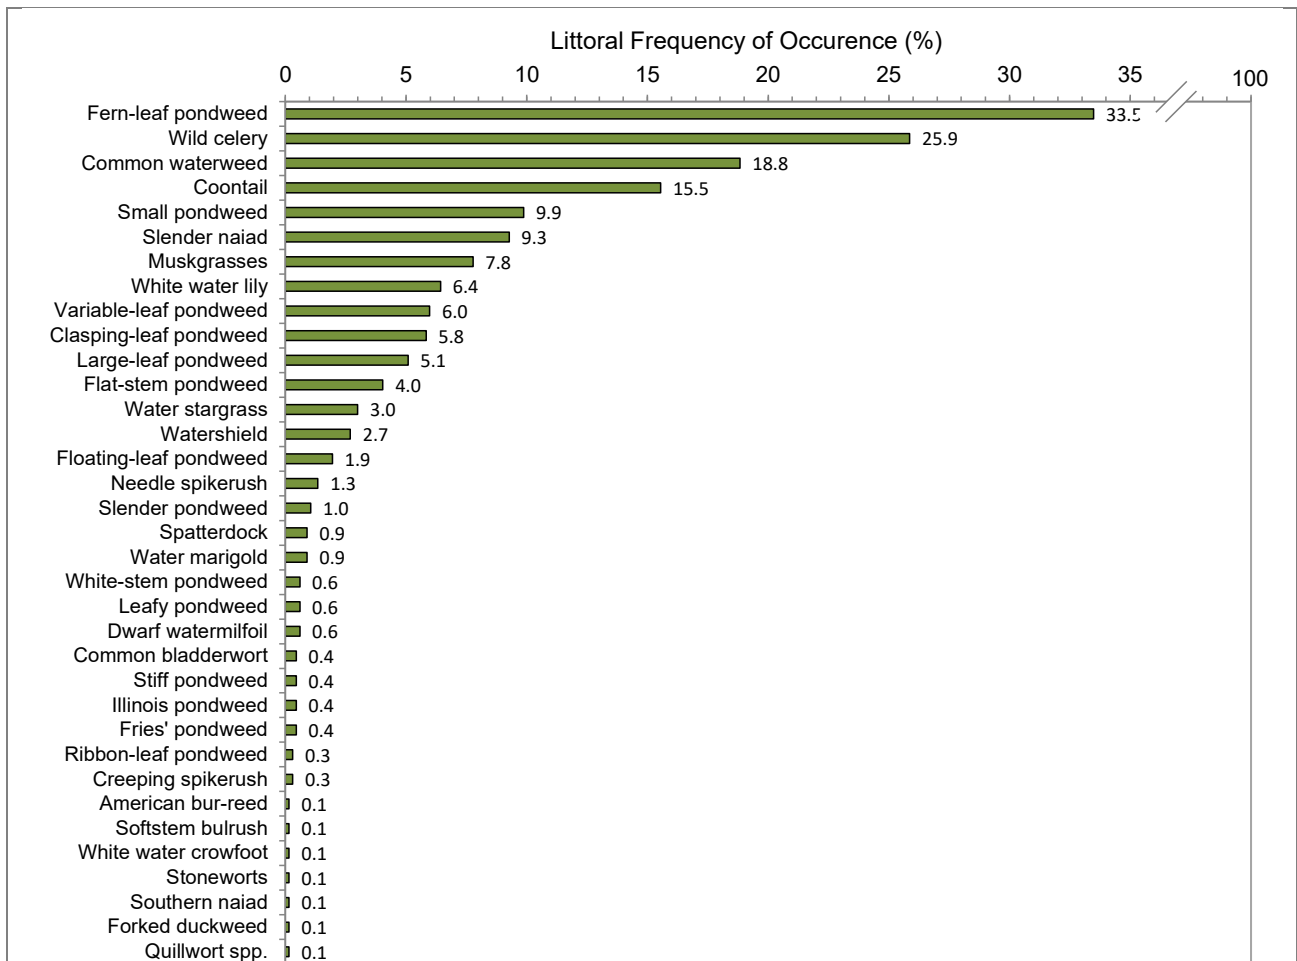
Figure 6.5-1. 2023 Littoral Frequency of Occurrence of aquatic plant species in Eagle Lake.

A total of 35 species were physically encountered on the survey rake during the 2023 survey with fern-leaf pondweed, wild celery, and common waterweed being the most-frequently encountered native aquatic plant species. The maximum depth of plant growth in the 2023 survey was 39 feet which is significantly deeper than past surveys and deeper than plants have been found in other lakes in the system. Species located at depths of 36-39 feet in the 2023 survey included coontail, small pondweed, and common waterweed.

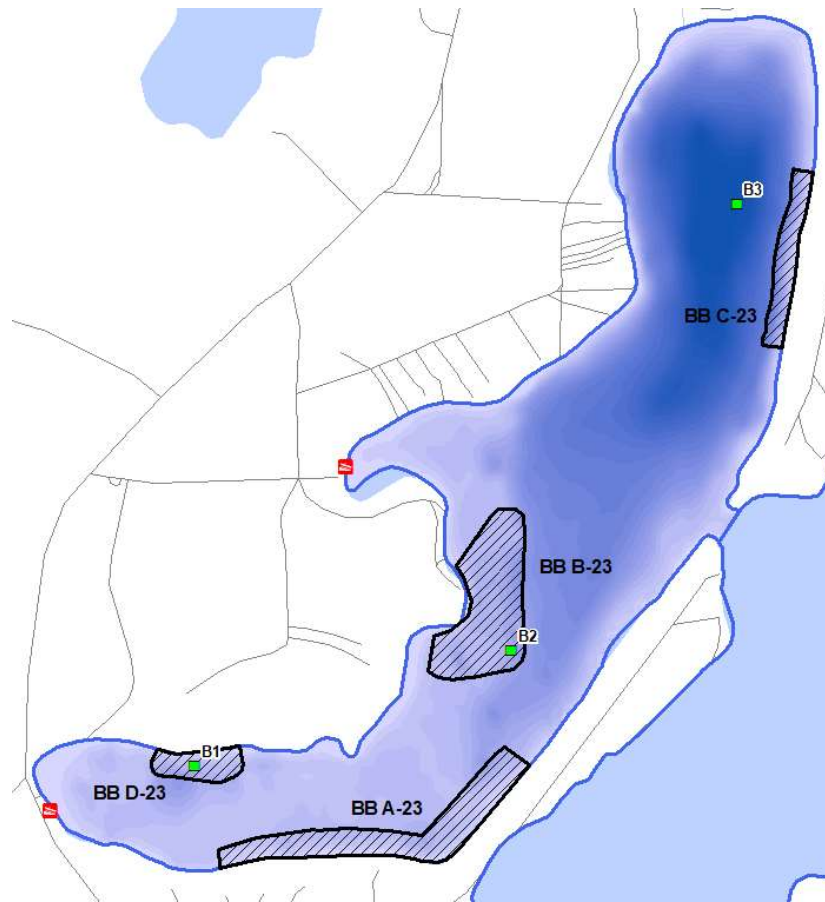
Water samples will need to be collected at the sites and depths listed below. Coordinates are in decimal degrees. Locations of each sampling site are displayed with green squares on the image below.

Buskey Bay Herbicide Sample Sites					
Site Label	Site Description	Station ID	Latitude	Longitude	Sample Depth
B1	Application area	10057529	46.524552	-91.380909	Integrated (0-6 feet)
B2	Near center	10048393	46.52601	-91.37538	Integrated (0-6 feet)
B3	Deep hole	10020502	46.53147	-91.37155	Integrated (0-6 feet)

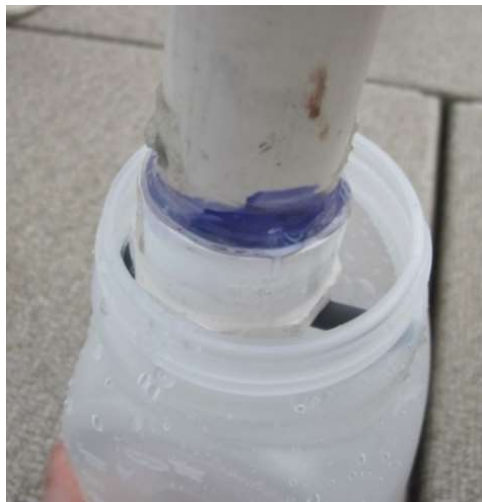
Photo 2. Emptying the water sample from the integrated sampler device into the custom mixing bottle.

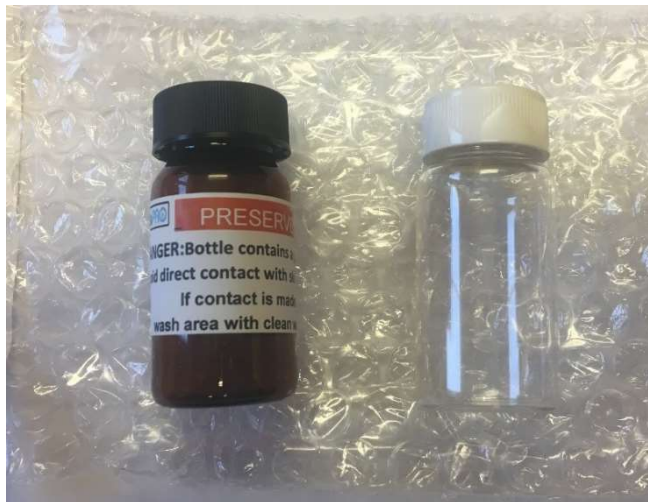
Photo 3. Clear glass mixing bottle and final brown glass bottle.

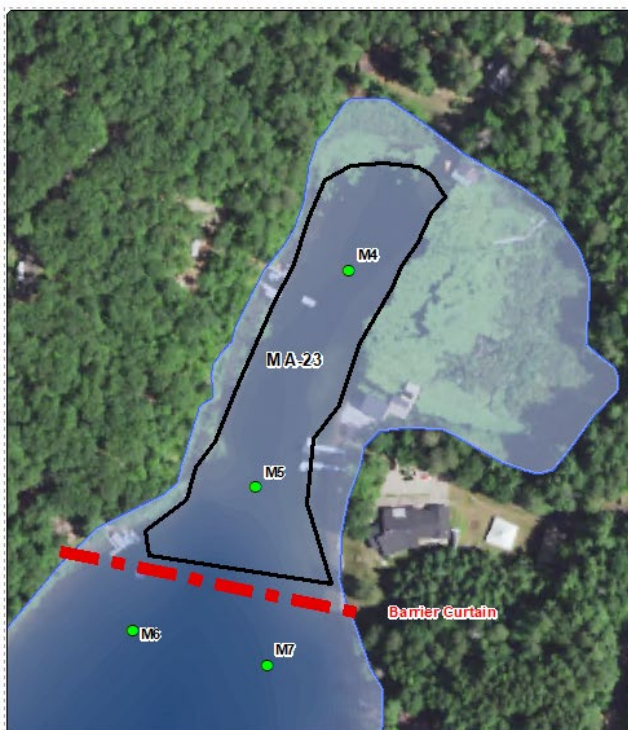
Water samples will need to be collected at the sites and depths listed below. Coordinates are in decimal degrees. Locations of each sampling site are displayed with green squares on the image below.

Lake Millicent Herbicide Sample Sites					
Site Label	Site Description	Station ID	Latitude	Longitude	Sample Depth
M4	Application Area M A-23	10057532	46.53896	-91.36197	Integrated (0-6 feet)
M5	Application Area M A-23	10057533	46.53800	-91.36254	Integrated (0-6 feet)
M6	Outside Application Area	10057534	46.53736	-91.36332	Integrated (0-6 feet)
M7	Outside Application Area	10057535	46.53722	-91.36245	Integrated (0-6 feet)

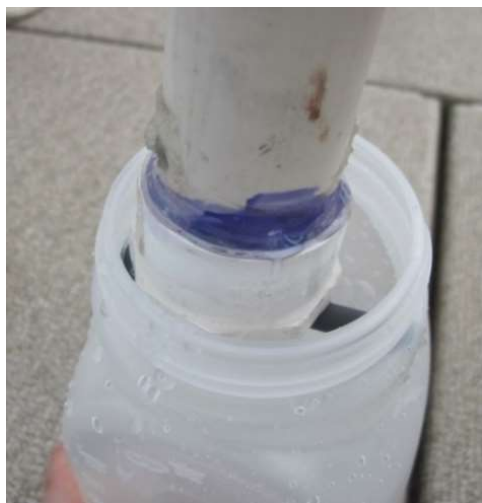
Photo 2. Emptying the water sample from the integrated sampler device into the custom mixing bottle.

Due to the extremely low concentrations being measured at the laboratory (<1 part per billion), **it is very important to thoroughly rinse the integrated sampler device and the custom mixing bottle with the water from each sampling site upon arrival at the site.** Water is collected by pushing the integrated sampler straight down to a depth of six feet; or in water shallower than six feet, down to approximately one foot above the bottom sediment. The sampler is brought to the surface and emptied into a customized mixing bottle by pushing open the stop valve at the end of the integrated sampler (Photo 2). Water should be poured from the custom mixing bottle to triple rinse the clear glass bottle. After the clear glass bottle is triple rinsed, it is to be filled for a fourth time with the water from the custom mixing bottle and then carefully poured into the brown glass bottle which has a preservative solution already inside (Photo 3).

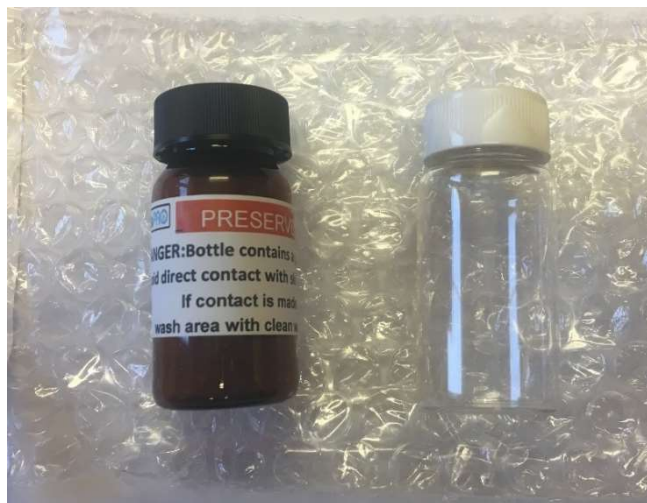
Photo 3. Clear glass mixing bottle and final brown glass bottle.
